**Re: CPF 3-2012-5013 L6B Marshall Michigan – Enbridge Response to July 2012  
Notice of Probable Violation and Proposed Civil Penalty**

The twenty-four violations proposed by the NOPV relate to a crude oil release of approximately 20,082 barrels on July 25, 2010 from Enbridge’s 30-inch diameter Line 6B pipeline near Marshall, Michigan. The NOPV proposes a civil penalty of \$3,699,200.

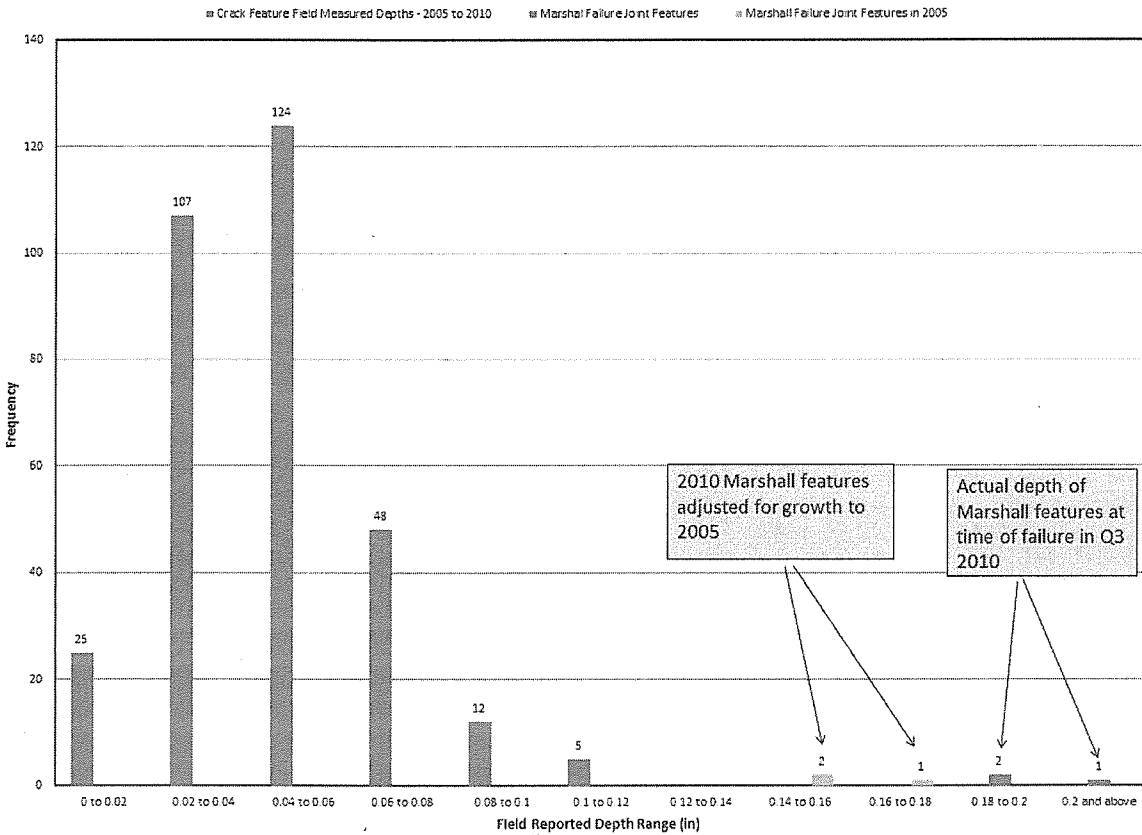
**Figure 3**

**Post-Accident Inspection and Analysis.** Based upon the trending and calibration activities undertaken for the Line 6B crack ILI and dig program, all evidence suggested that the USCD ILI tool was accurately reporting the size of features. However, the Marshall feature significantly deviated from the trend and calibration results. The depth distribution for field assessed crack features is included in Figure 3 below:

The red bars show the depth of the Marshall features as found in 2010 and the green bars show the 2010 features, adjusted for growth, as they would have appeared in 2005. The estimated depths in 2005 have been calculated post-Accident using a linear time-averaged SCC growth rate of 0.15 to 0.2 mm/year. This value is considered to be a reasonable estimate based upon industry SCC growth rate ranges and the pressure cycling spectrum that occurred at the Marshall location between 2005 and 2010. The estimated depths of the Marshall features in 2005 (the time of the USCD inspection) are well in excess of any features identified in the ILI tool report or through the subsequent dig program. Based upon the trend and calibration analyses, there was no evidence to suggest that such a significant feature existed on the pipeline.
